February 2025

Terrace and De Soto Streets Pedestrian Safety and Traffic Study

Final Report

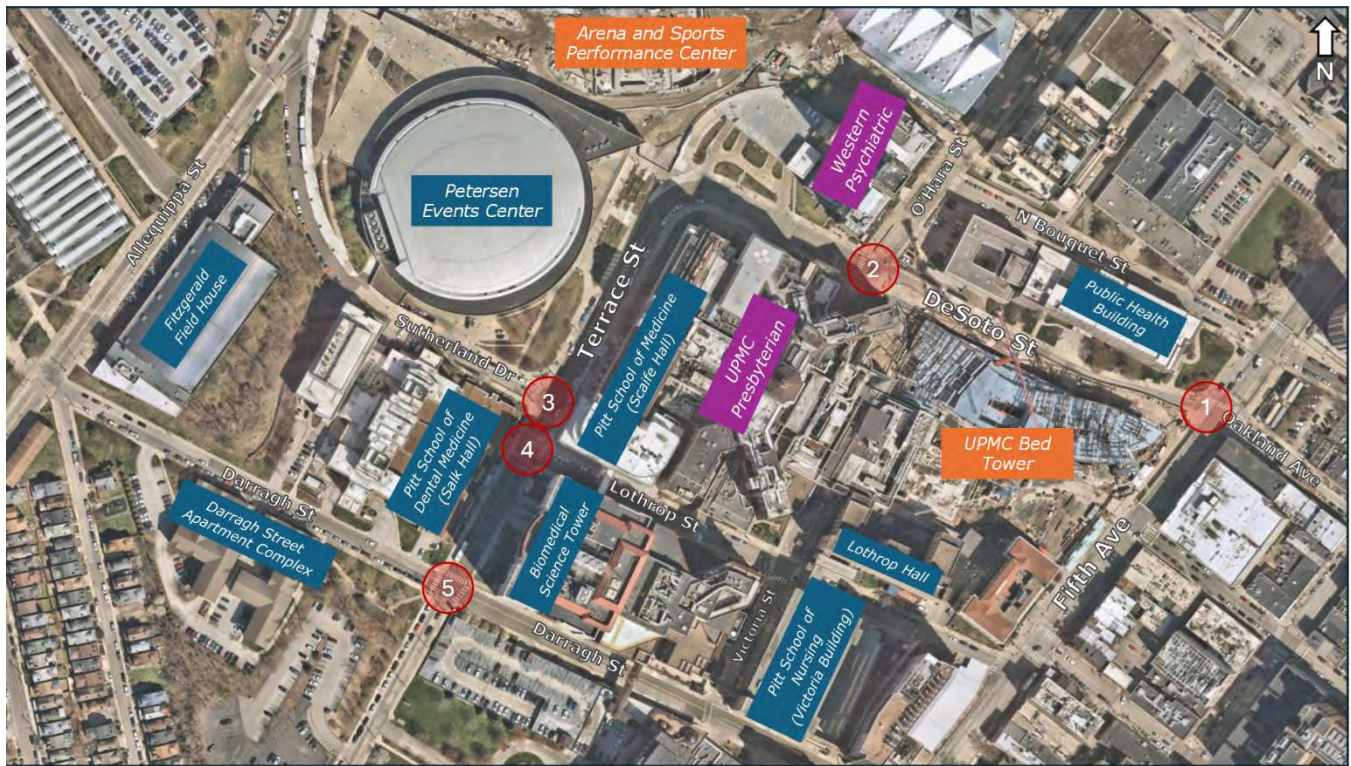
Figure 1: Study Area

The study area considered is shown in **Figure 1** and includes five intersections along De Soto Street and Terrace Street, between Fifth Avenue and Darragh Street. From 2019 to 2023, the area experienced 28 crashes, 7 involving pedestrians, two of which resulted in fatalities. Near-miss incidents, which often go unreported, are frequent.

- Existing University of Pittsburgh Facility
- Existing UPMC Facility
- Facility Under Construction
- Study Area Intersection

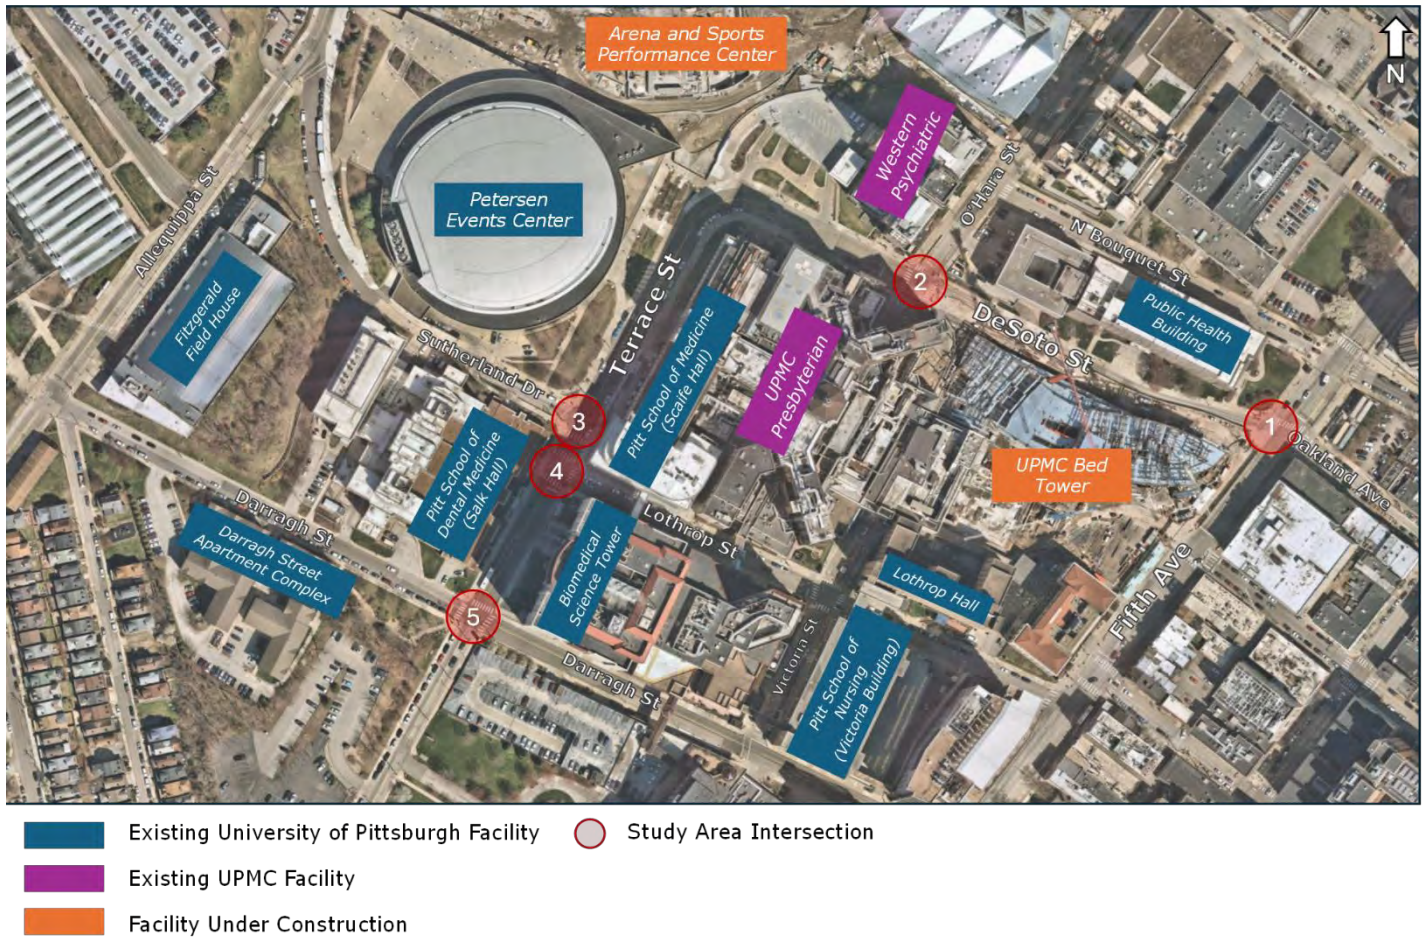
Figure 2: Project Site Area and Study Intersections

The project study area encompasses five intersections along the Terrace Street/De Soto Street corridor, as shown in **Figure 2** on the next page. All streets in the study area are owned by the City of Pittsburgh, with the exception of Sutherland Drive, which is privately-owned by the University. It begins with the intersection of Fifth Avenue and De Soto Street and continues until the intersection of Terrace Street and Darragh Street. Throughout this report, the direction of De Soto Street will be referred to as “north-south” and the direction of Terrace Street will be considered “east-west”.

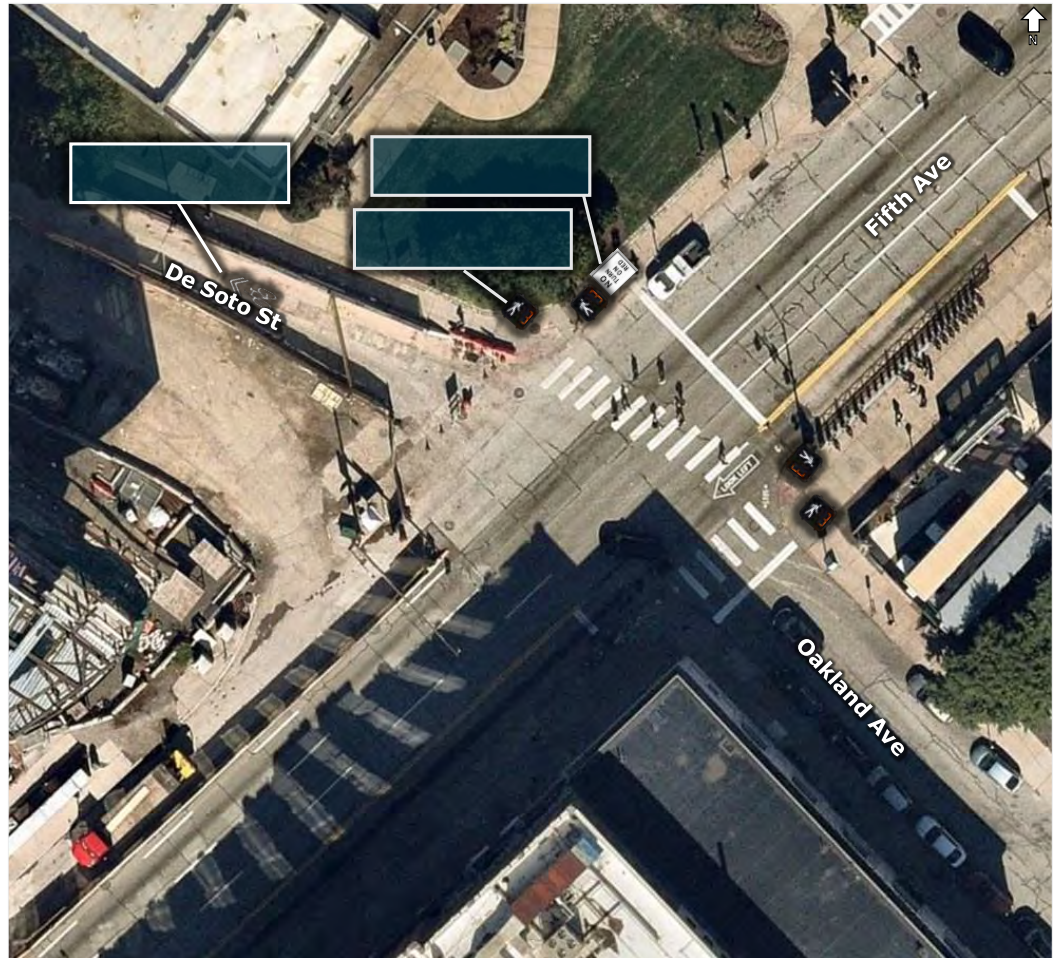
Pedestrian compliance with traffic signs/signal is a challenge along the entire study corridor. At the intersection of Fifth Avenue and De Soto Street/Oakland Avenue, a leading pedestrian interval (LPI) is recommended to increase the visibility of pedestrians in the intersection. Additionally, coupling the LPI with additional 'No Turn on Red' signage along Fifth Avenue reduces the potential for pedestrian-vehicular conflicts. Lastly, bicycle sharrow markings should be installed to direct multimodal users to use the traffic lane, rather than the

sidewalk. The bicycle sharrow markings should be installed with the appropriate bicycle signage to warn drivers.

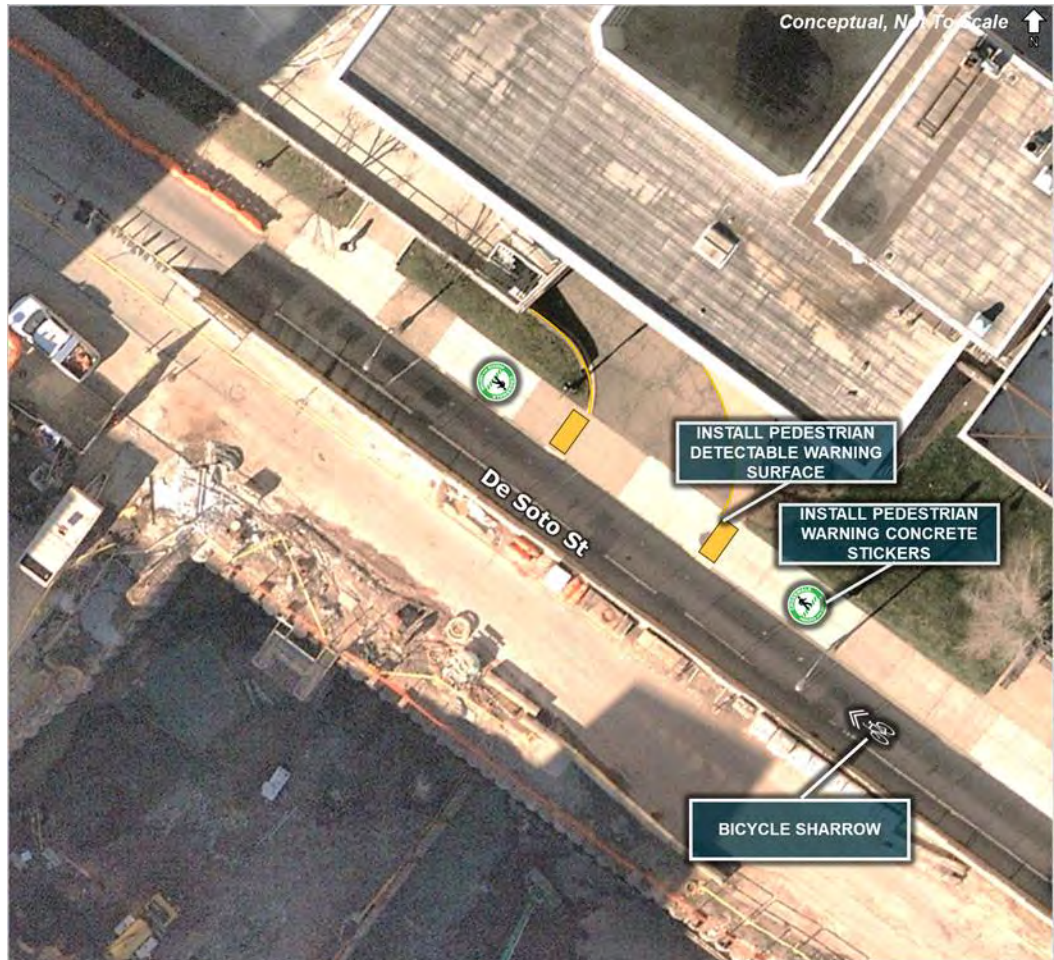
As pedestrians travel uphill from Fifth Avenue towards O'Hara Street, there are two garage driveways. As noted in the existing conditions assessment, there is limited sight distance entering and exiting the garages and there are no signage or pavement markings denoting that a pedestrian is entering an active driveway. In the short term, it is recommended to install pedestrian warning stickers on the sidewalks to alert pedestrians of the oncoming driveway. Additionally, pedestrian detectable warning surfaces may be installed to improve accessibility and provide an additional way of alerting pedestrians of the oncoming garage driveway.

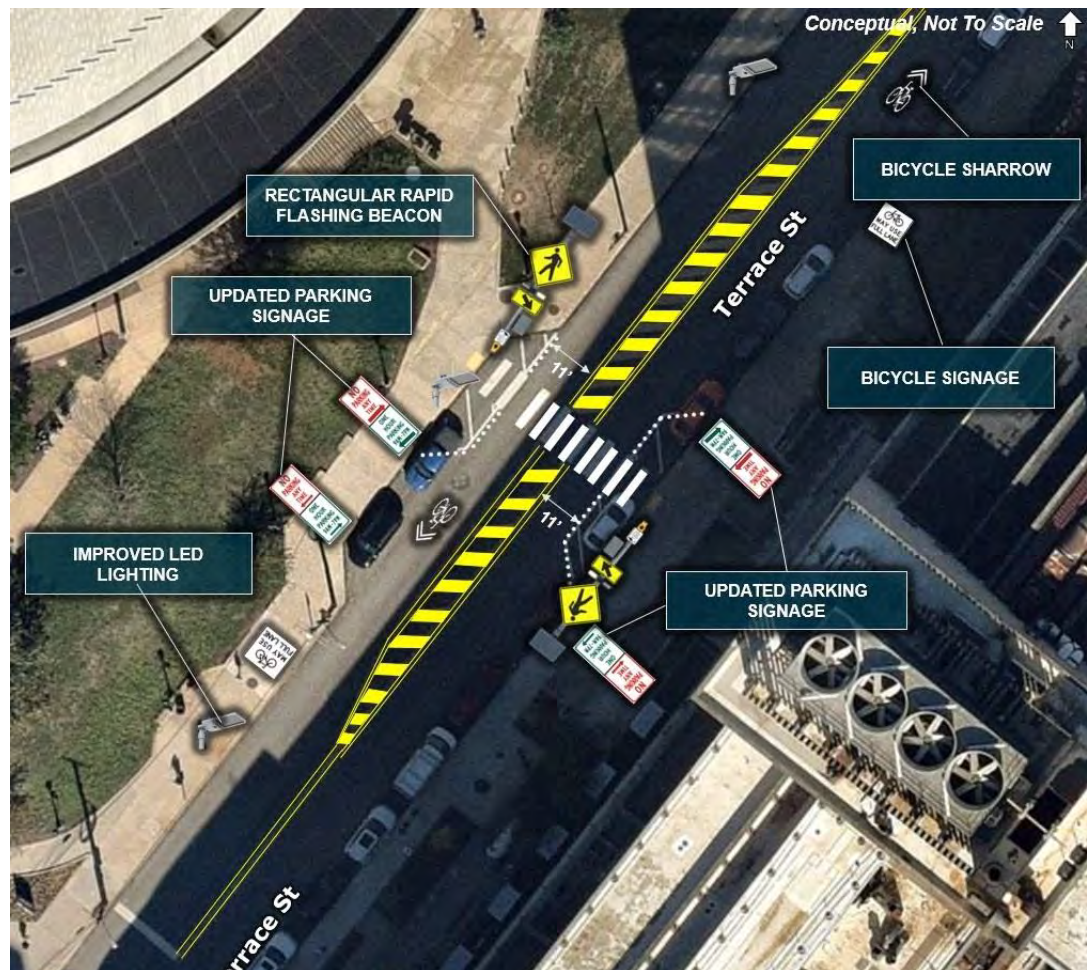
In the short term, improvements to the midblock crossing on Terrace Street are recommended to improve awareness of this crossing. Consistent with the recommendations at other areas of the corridor, parking signage and pavement markings should be improved and made more visible. As noted during the existing conditions phase, there is insufficient lighting along this stretch of the corridor as several lights were out. Thus, it is recommended to increase lighting by

addressing the nonfunctioning light fixtures and to replace all cobra-head light fixtures with improved LED lighting. Near the crossing, many drivers continue to park in the hatched areas despite the No Parking signage and proximity to a crosswalk. It is recommended in the short term to install flexible delineators to restrict drivers from parking in the hatched areas. This will also provide additional separation between drivers and pedestrians waiting to cross. Lastly, to increase driver awareness to pedestrians within the crosswalk, rectangular rapid flashing beacons (RRFBs) are recommended. RRFBs consist of two, rectangular-shaped yellow indications, each with a

LED-array-based light source. RRFBs flash with an alternating high frequency when activated to enhance visibility of pedestrians at the crossing to drivers. These should be installed closest to the driver's side in each direction and should be dual faced. Typical RRFBs require a pedestrian to push a button in order to alert drivers. However, pedestrian compliance is a challenge along the corridor. As funding allows, the University should look to install non-actuated or automatic RRFBs to combat this challenge. As a pedestrian walks past the RRFB to cross, it will automatically alert drivers by flashing lights.

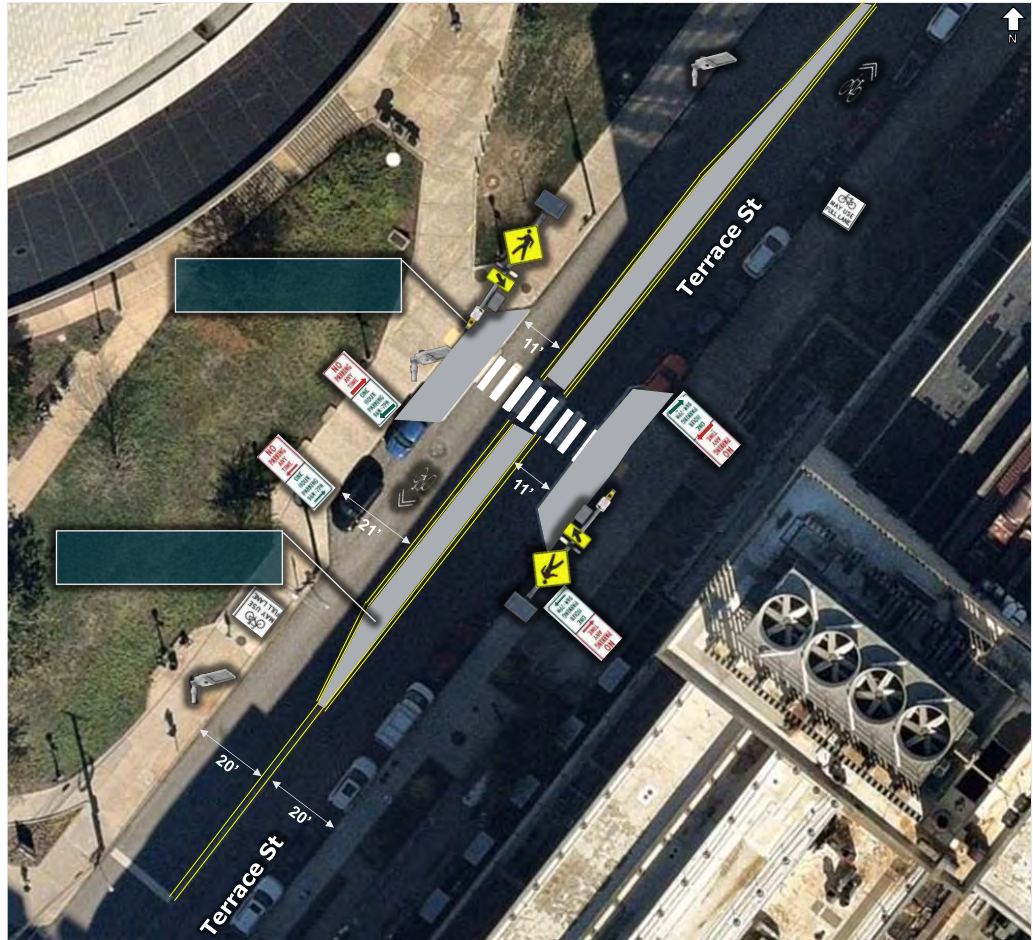
An alternative mid-term recommendation for the Terrace Street midblock crossing includes installing permanent curb bump outs on both sides of Terrace Street. Curb bump outs or extensions visually and physically narrow the roadway, creating safer and shorter crossings for pedestrians while increasing the available space for street furniture, benches, plantings, and street trees. Additionally, a concrete median should be installed to reinforce slower driver speeds along the corridor and provide refuge to pedestrians.

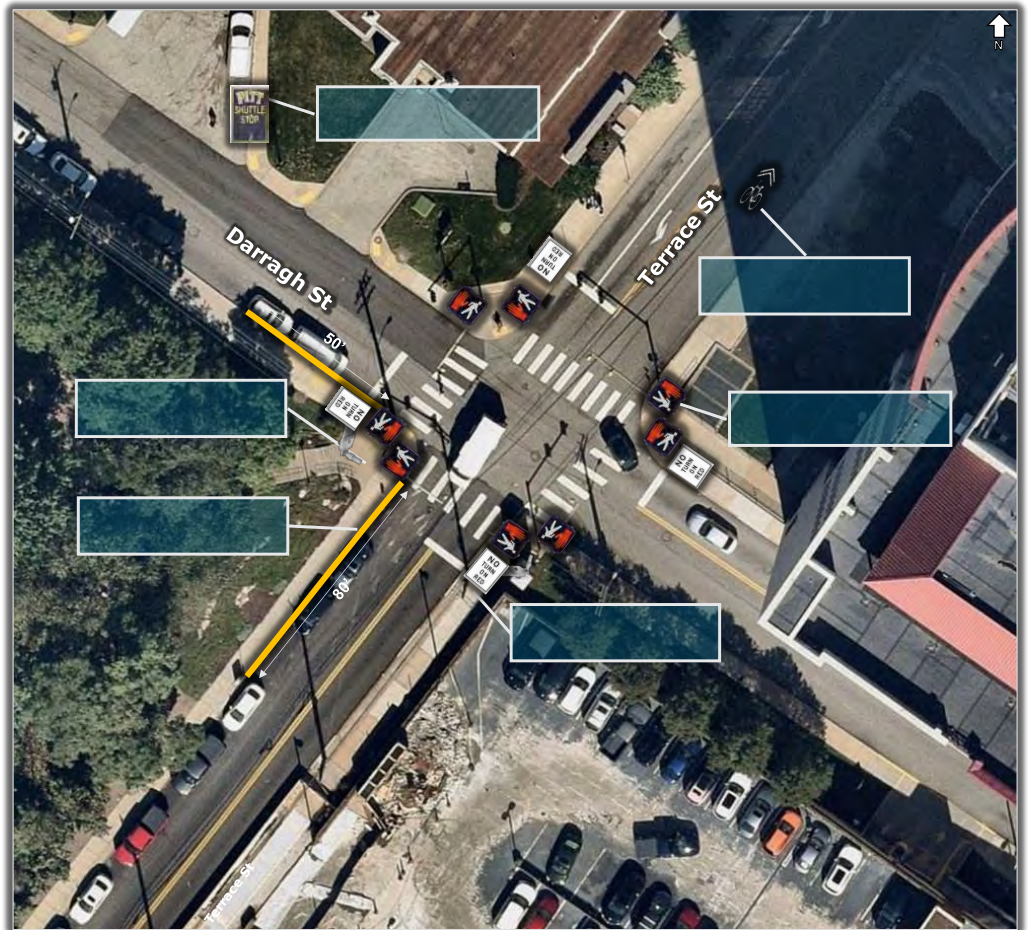
In the short term, improved parking signage, No Turn on Red signage, and pavement markings are recommended. As with other intersections along the corridor, improved LED lighting is recommended to increase visibility. Similar to the other signalized intersections in the study corridor, a leading pedestrian interval should be implemented to improve pedestrian visibility. Lastly, it is recommended to relocate the existing Pitt shuttle stop from the corner of Terrace Street and Darragh Street to approximately 85 feet north near the Salk Hall loading dock driveway. This will reduce the queuing that builds up through the intersection, thereby reducing conflicts between stopped cars and pedestrians within the intersection. The recommendations for No Turn on Red signage, LPIs, and yellow “no parking” curb paint were implemented in December 2024.

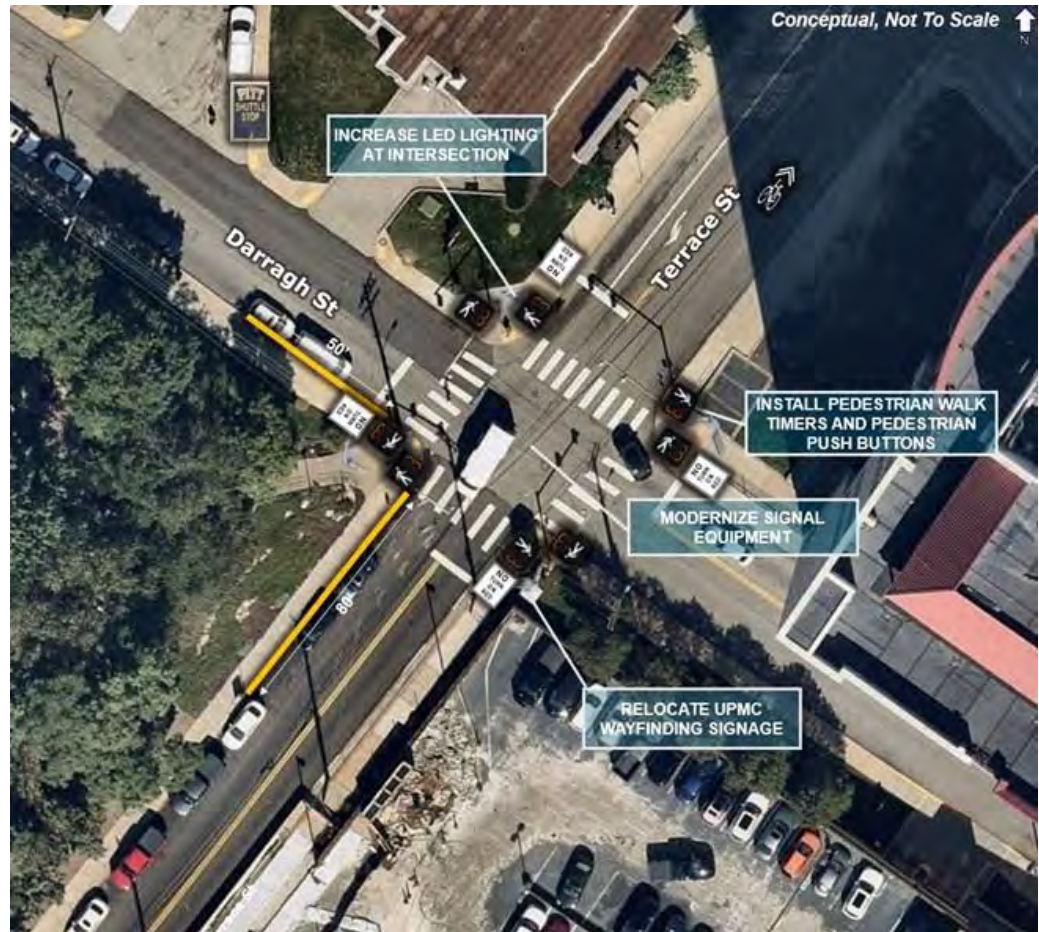
In the mid-term, it is recommended to relocate the existing UPMC wayfinding signage. This existing sign obstructs driver sight distance, making it difficult for drivers to notice pedestrians in the crosswalk. Lastly, all signal equipment, including new pedestrian walk timers and push buttons, should be installed. This includes retroreflective backplates on signal heads which improves visibility during day and nighttime conditions. Additionally, a pedestrian walk timer will display the number of seconds pedestrians are left for a pedestrian to finish crossing the street. These timers will

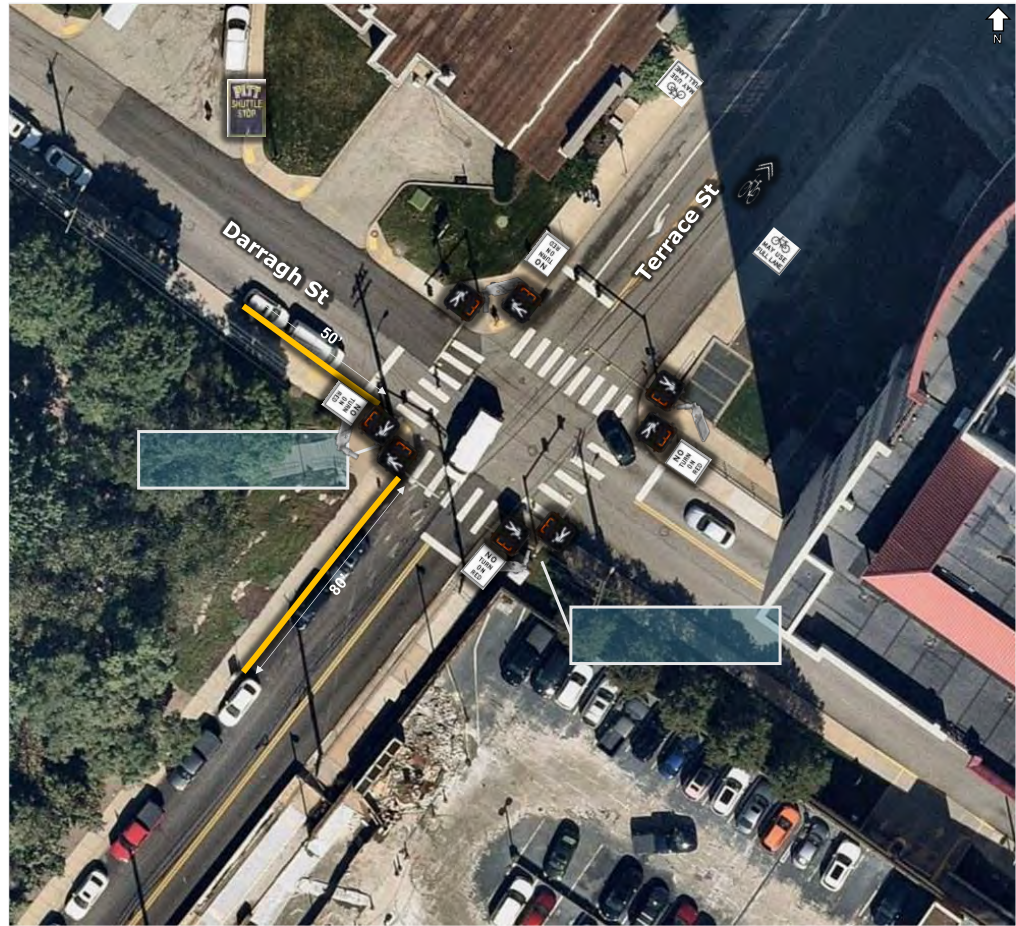
The existing utility structures create sight distance challenges at the intersection of Terrace Street and Darragh Street. Depending on the feasibility of and funding available, it is recommended to move existing mast arms and utility poles further outside of the intersection, or at the minimum, outside of the landing area of each curb ramp. During the field assessment, the project team noted the existing utility poles restrict sight distance for vehicles and conflicts with the landing areas of crosswalk curb ramps. By relocating the existing utility poles, these crosswalk curb ramps will become more accessible.
